MEMORANDUM

DATE:	August 15 th , 2016
FROM:	Eric Lancaster
SUBJECT:	Weekly Progress Report @ Gold King
TO:	Kerry Guy

Project: Gold King Interim Water Treatment Plant (IWTP)

Report No.: 32

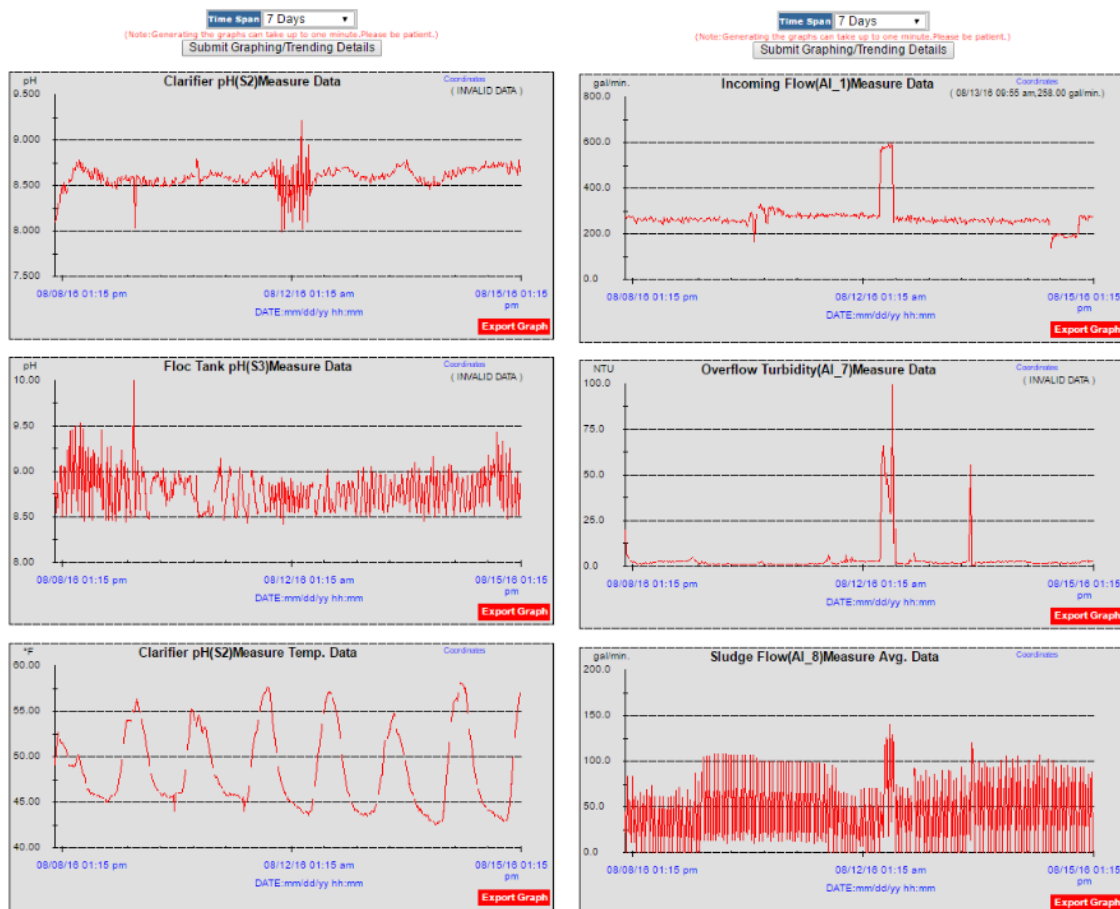
- The following graphs provide trending information during the previous 7 days. The dataloggers collect control information from the Lime Circuit (left) and Flow Circuit (right) Programmable Logic Controllers (PLCs) at the Gold King IWTP. Over the reporting period (8/8/16 – 8/15/2016 inclusive) Alexco treated 5.88 million gallons at an average flow rate of 583 gpm.

- Please note: Several days each week, the Alexco operators check the pH at both the flocc tank and clarifier discharge. During this time, the probe is placed in vinegar (acid), and three pH buffers – 4, 7, and 10. While the probe is in the acid/buffer, the datalogger may capture one of those points for tracking purposes, which explains the occasional pH spikes seen on the graph. In addition, instantaneous spikes of the Overflow Turbidity Meter are associated with routine cleaning, which can cause the meter to spike temporarily up to 100 NTUs.

- A pH sample from the IWTP inlet on 8/11 measured 3.51.
- A pH sample from the IWTP inlet on 8/12 measured 3.54.
- On 8/12 the Phase II clarifier was shut-off for several hours, allowing all incoming flow to pass through the Primary clarifier. This is why the incoming flow spiked during that time, and the turbidity was higher.

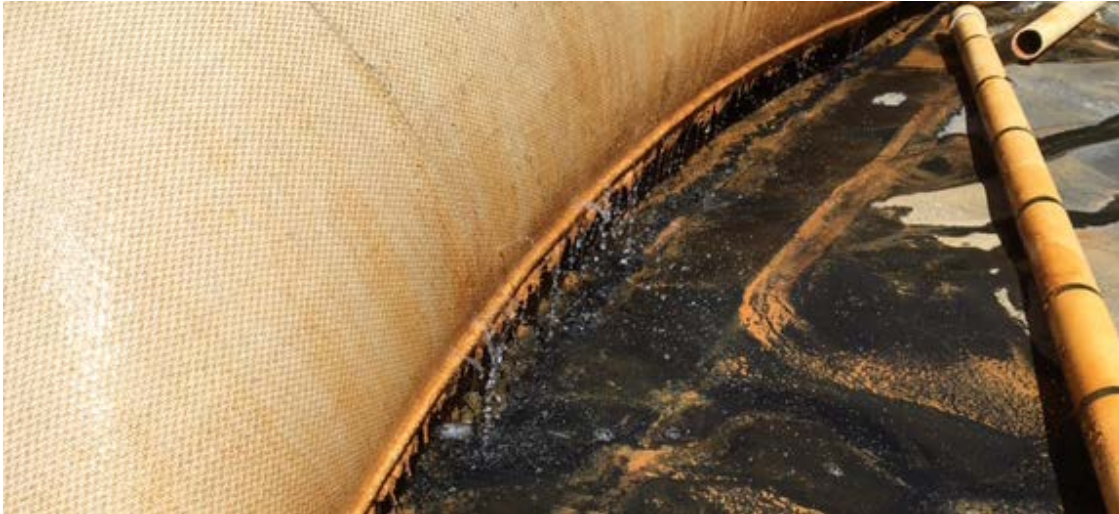
- Cell D is scheduled for re-lining by Lange Containment on Tuesday (8/16).
- There is concern that the A and B bags are full, and Alexco is currently filling bag C at times to allow the other bags to dewater. Alexco will continue to minimize bag C usage while focusing on utilizing bags A and B.

Photo 2: Discharge from Bag A
